# **INITIAL ASSESSMENT STUDY OF NAVAL WEAPONS STATION, CONCORD, CALIFORNIA**

## **NEESA 13-013**

**INITIAL ASSESSMENT STUDY  
NAVAL WEAPONS STATION, CONCORD, CALIFORNIA**

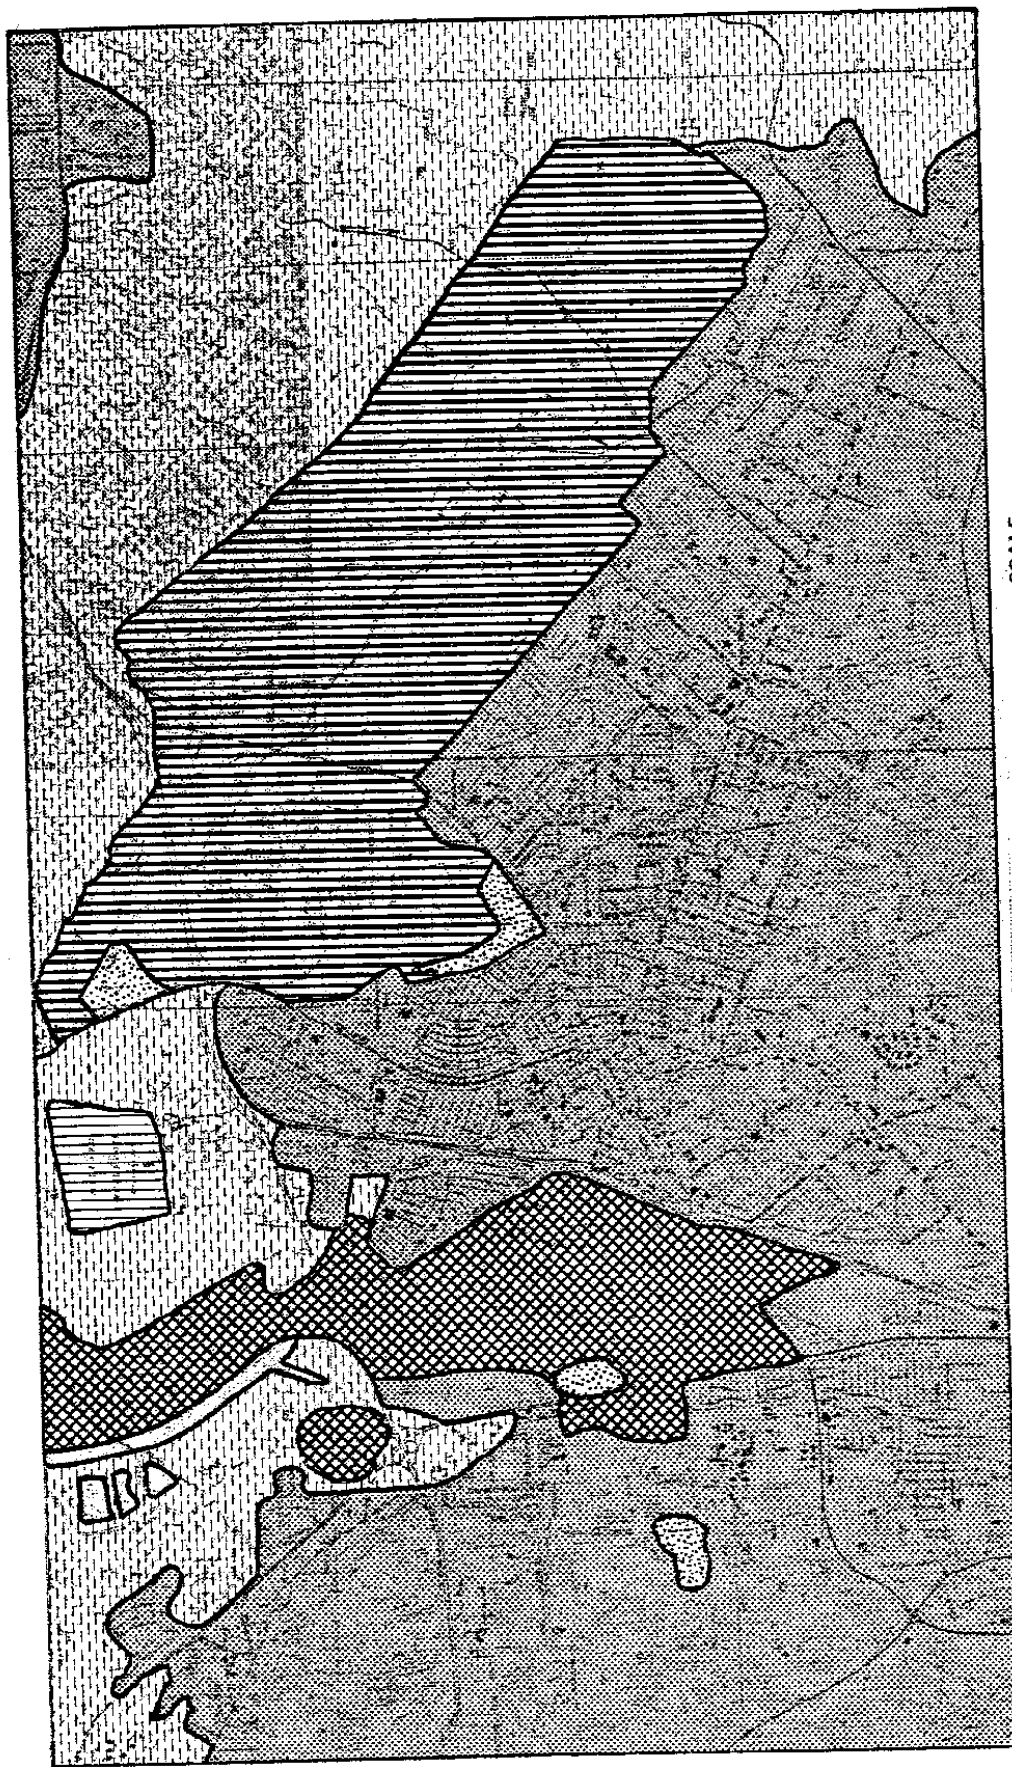
Figure 5-7 EXISTING LAND USE TIDAL AREA

5.5 ADJACENT LAND USE. Land use in the vicinity of NWS Concord is shown on Figures 5-7 and 5-8. Suisun Bay and a conglomerate of islands containing marshlands and numerous man-made levees are located to the north of the Tidal Area. As mentioned previously, Ryer, Roe, Freeman, Snag, and Seal islands are a part of the NWS Concord land-holdings. Portions of these islands are leased out to duck hunting

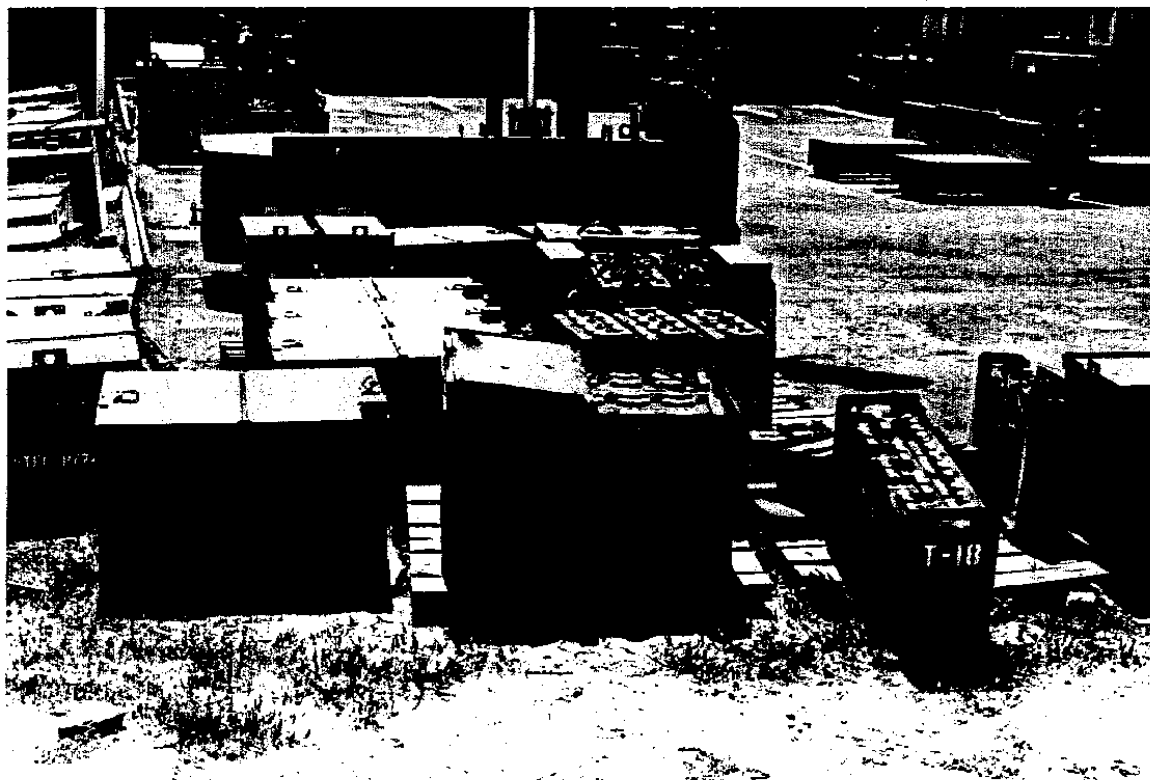
Figure 6-2 SPENT FORKLIFT BATTERIES, BUILDING IA24

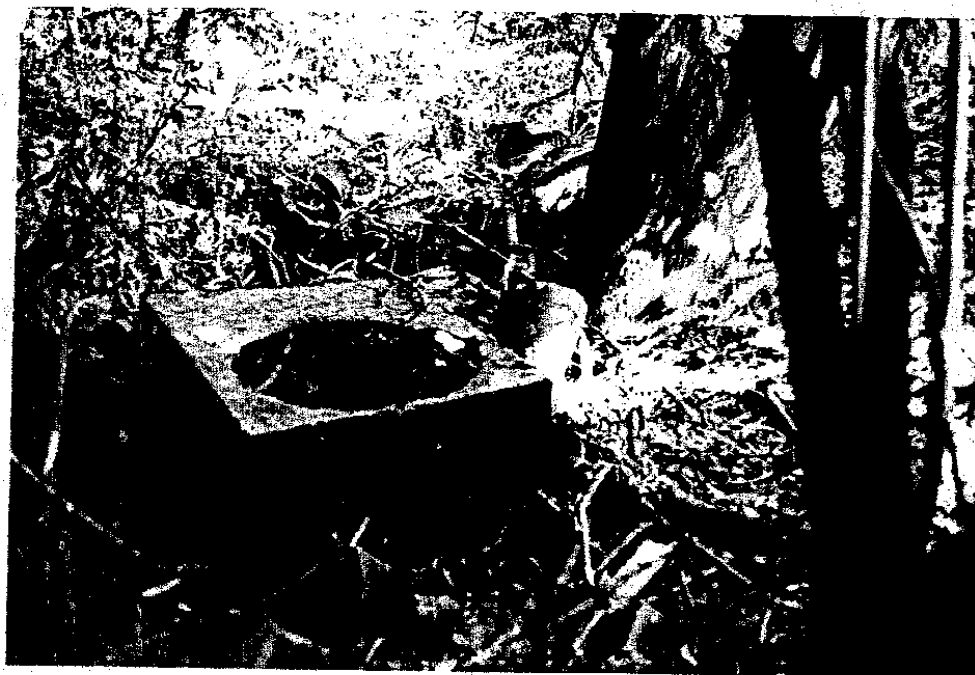
**Figure 6-7 OLD HOMESTEAD, SEAL CREEK (SITE 20)**  
This gully leading to Seal Creek is filled with cans, coffee pots, bed pans, and other household trash, possibly from an old homestead (June 1982).

The Old Homestead Site (Site 20) apparently resulted from the use of a gully as a disposal area for one of the ranches located in the area prior to its being accessed by the Navy in 1943. The debris in the gully includes old bottles, kitchen and household implements, cans, and other trash. Some of the bottles were dated from the 1920s; the kitchen implements are similar to items used in the earlier part of this century. No hazardous materials were apparent in the gully.

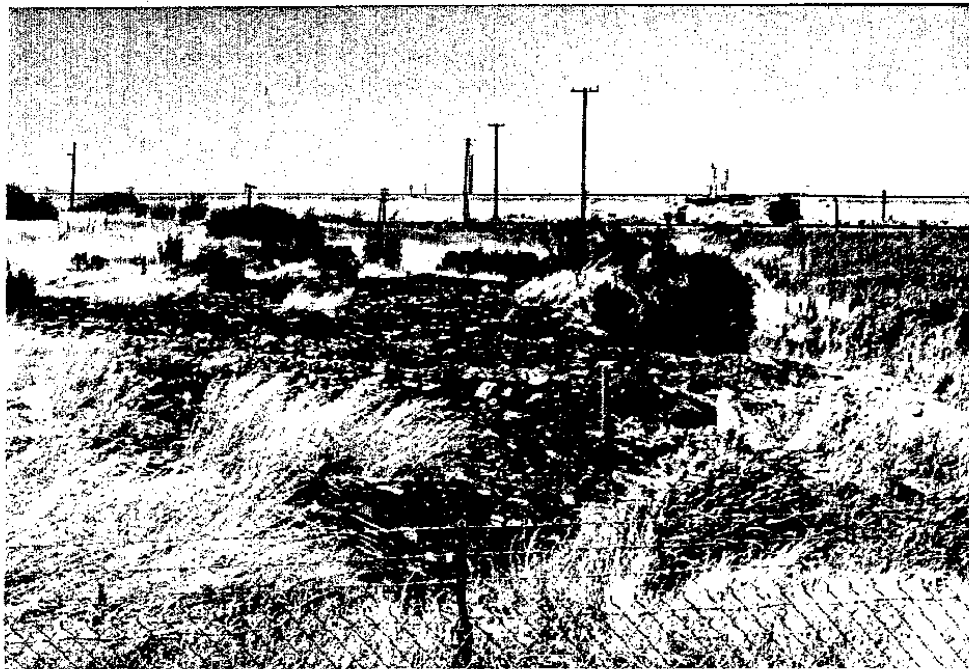
**Figure 6-10 COKE PILES (SITE 6), LOOKING NORTH**  
Note the absence of vegetation, the metal scrap mixed with the spent coke, and the marsh immediately to the right (June 1982).

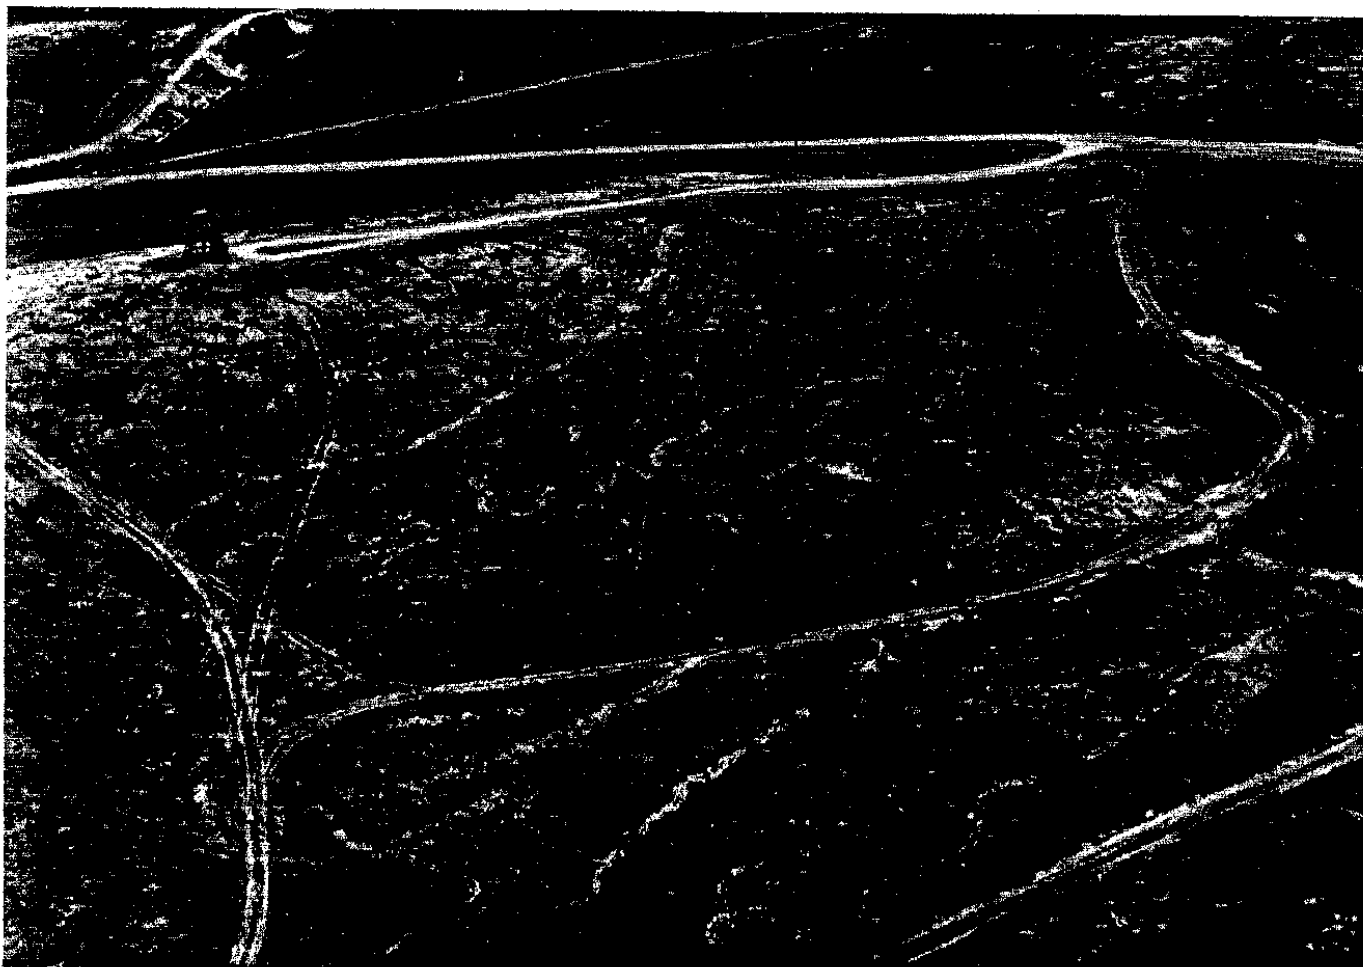
Figure 6-12 AERIAL VIEW, BURNING AREA (SITE 13) , LOOKING NORTHEAST  
The entire hillside below the fire tower has been used for ordnance disposal (May 1982).

Vegetation in the burning area itself is depressed. The soil surface is sunken. Debris, some of which has a black crystalline surface attached, is plainly visible (see Figures 6-12, 6-13, 6-14, and 6-15 in Section 6 of this report).

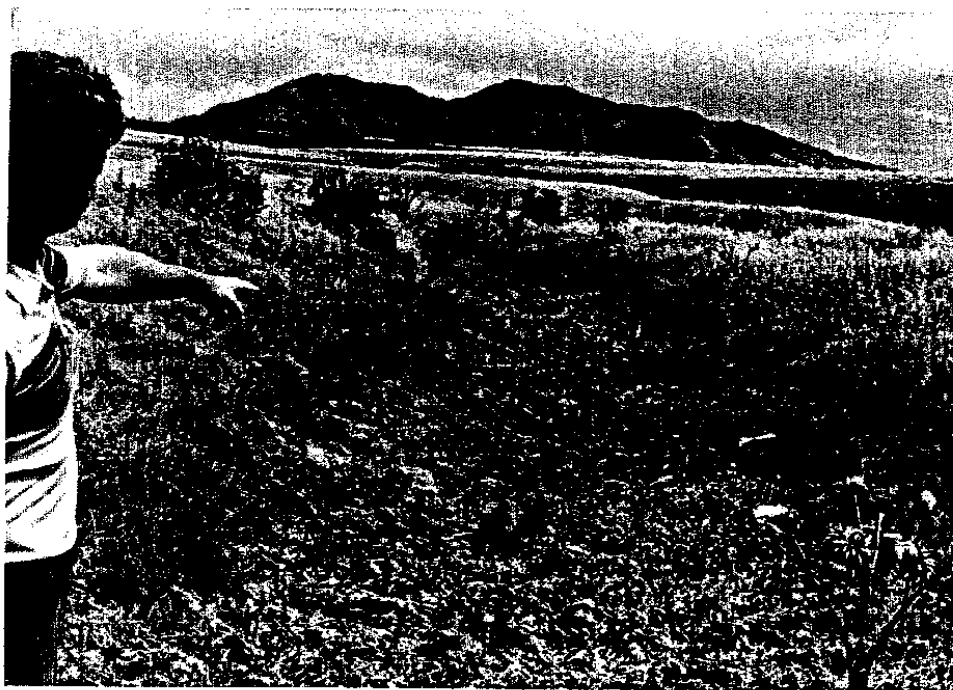
**Figure 6-14 BURNING AREA (SITE 13), LOOKING EAST**  
The depressed vegetation and sunken soil surface are plainly visible  
(June 1982).

Vegetation in the burning area is depressed and the soil surface is sunken. Debris, some with a black crystalline surface attached, is plainly visible.

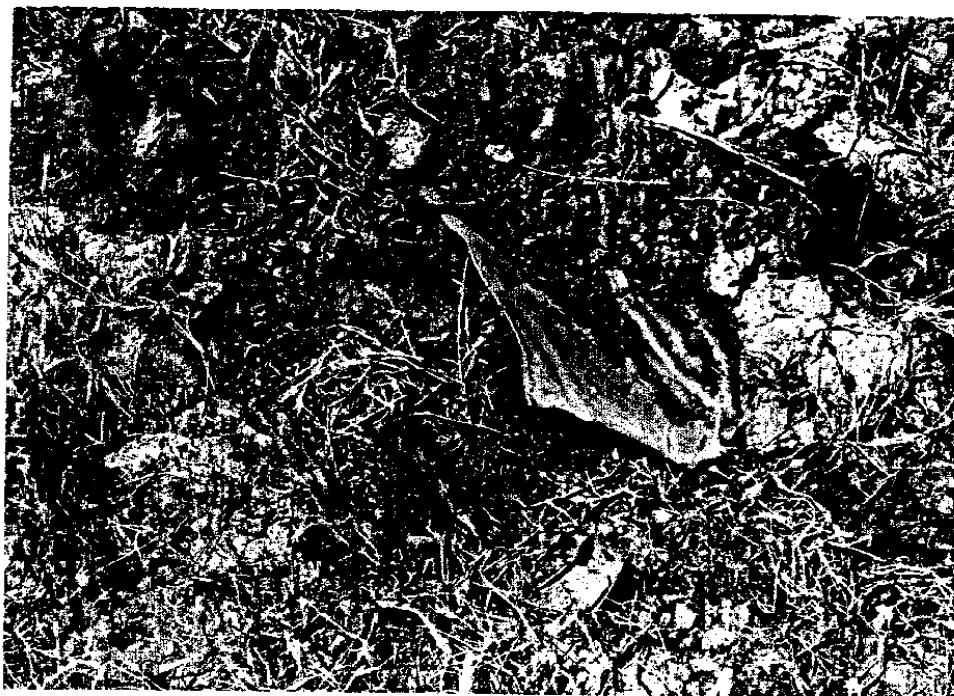
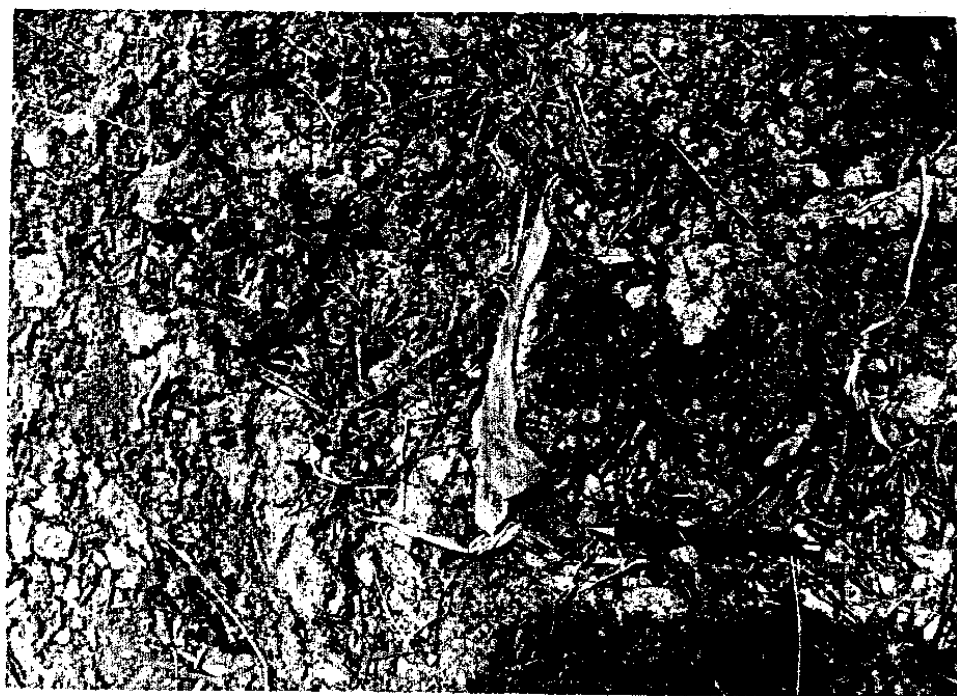
**Figure 6-15 DEBRIS IN THE BURNING AREA (SITE 13)**  
The bottom photograph shows a black crystalline substance attached to the scrap metal.
